**COMPREHENSIVE NEEDS ASSESSMENT FOR  
CHINOOK SALMON HABITAT IMPROVEMENT PROJECTS  
IN THE SAN JOAQUIN RIVER BASIN**

March 1994

Prepared for the California Department of Fish and Game  
by the  
California Department of Water Resources' San Joaquin District  
under Contract FG20841F/165038

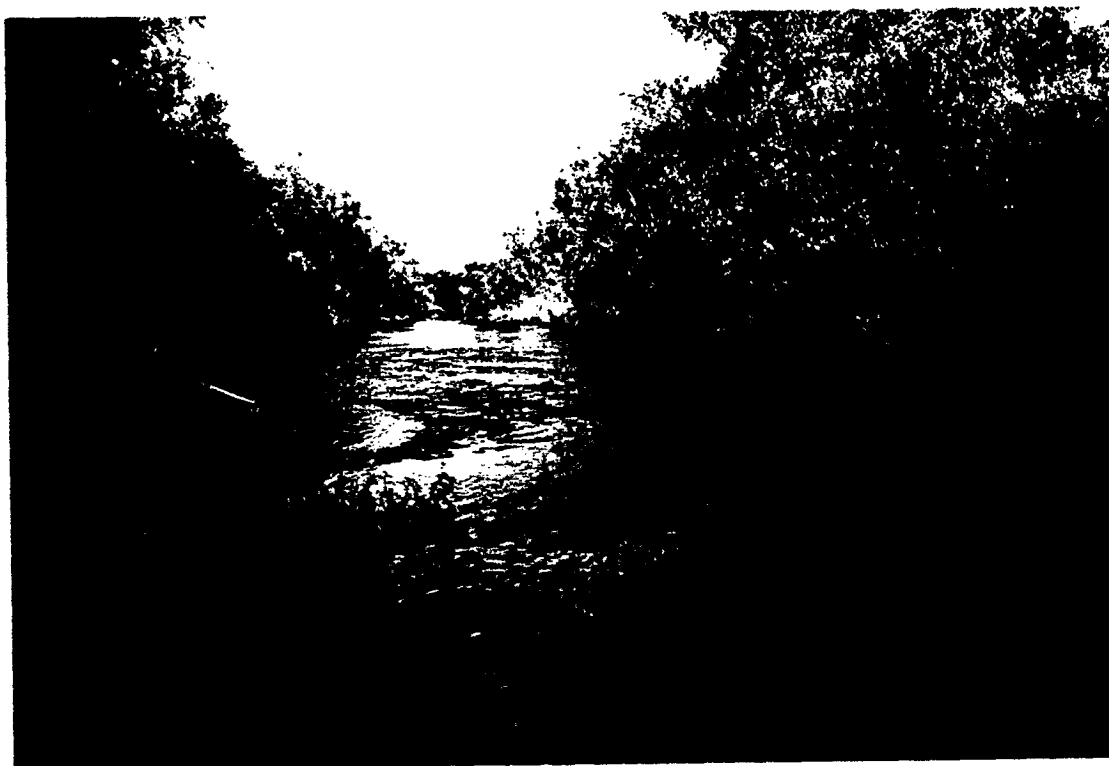
Stanislaus River, Lover's Leap.  
View looking downstream.

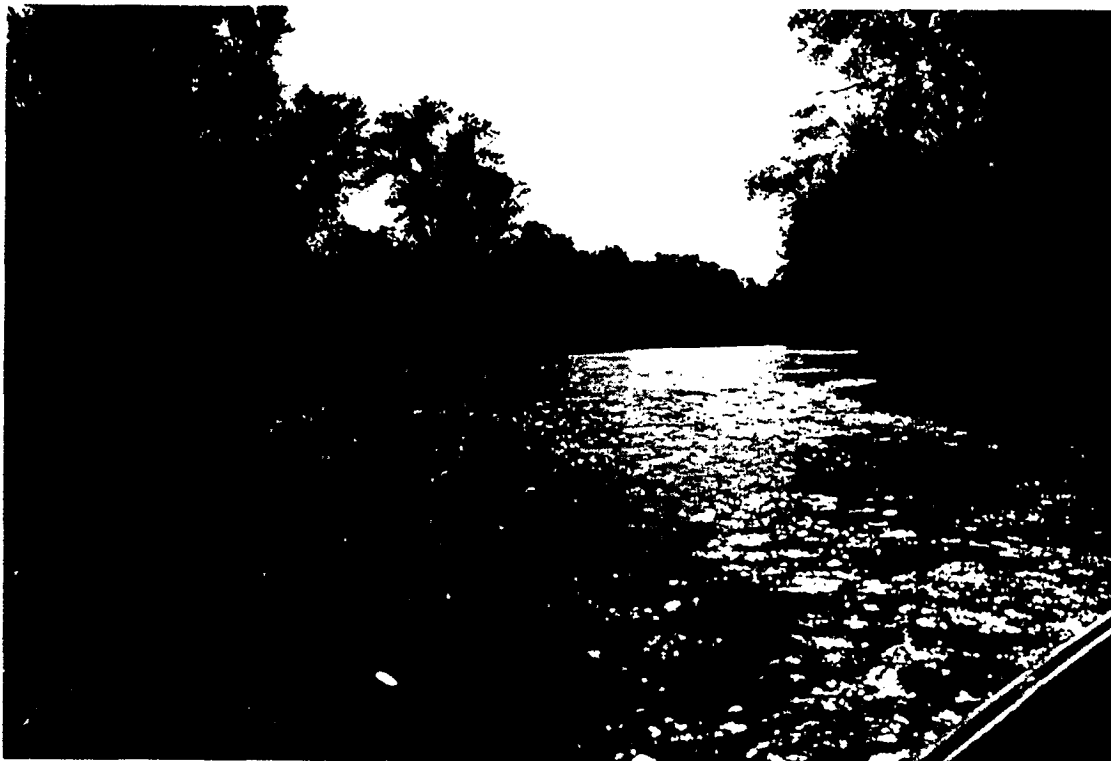
Stanislaus River, Mile 52.0, Lover's Leap.  
View looking upstream.

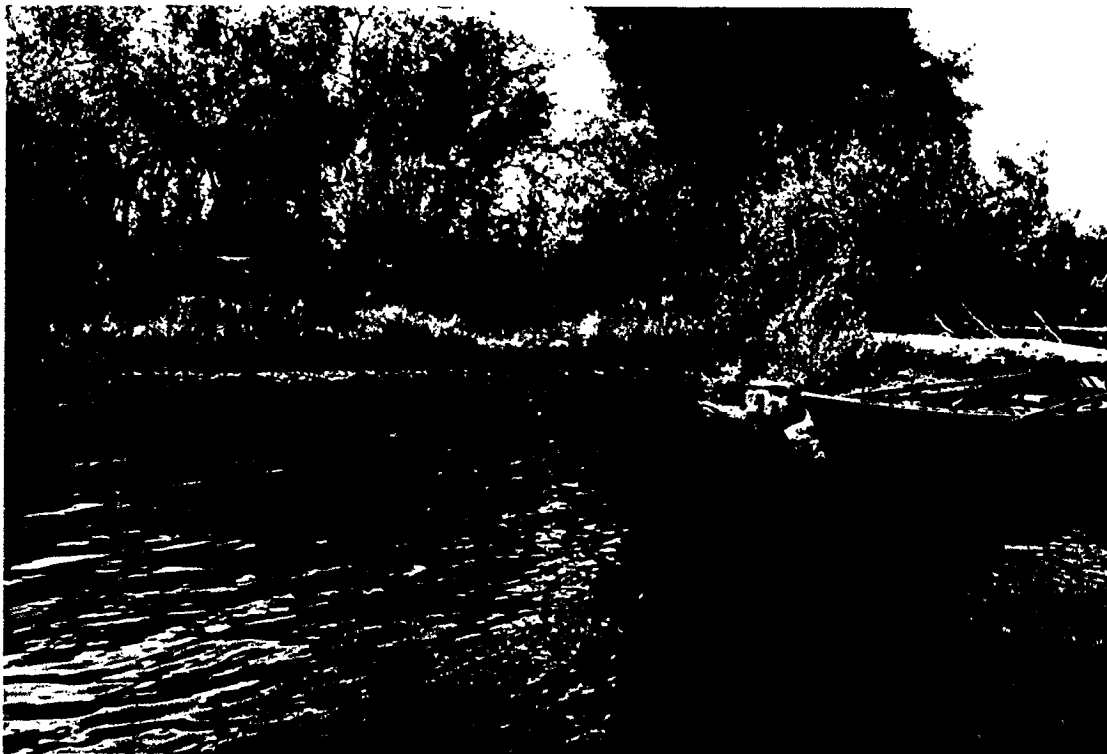
Stanislaus River, Mile 51.2, Graupner.  
View toward main channel from upstream end.

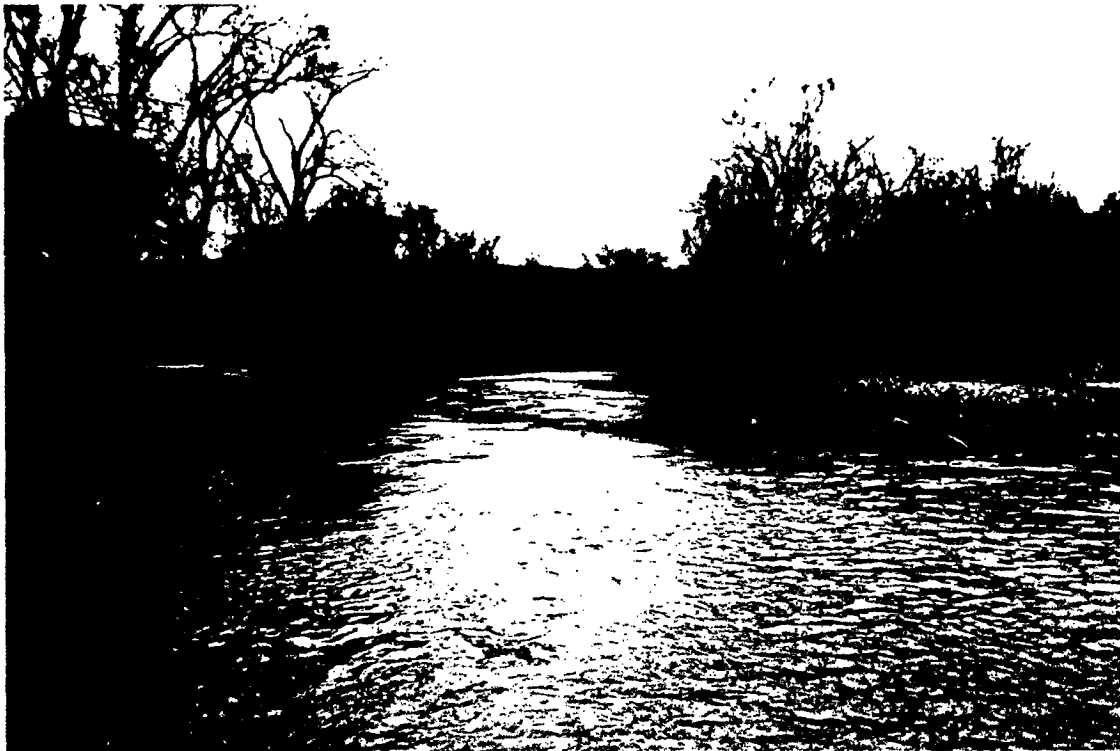
The current substrate is large cobble, laden with silt. The restored site will be approximately 80 feet wide and 950 feet long. Approximately 8,400 square yards of spawning gravel will be available after restoration.

Stanislaus River, Mile 48.8, Honolulu Bar.  
View looking downstream.

The restoration is roughly estimated to cost \$140,000 and take four weeks to construct. No significant permitting issues are seen at this time.

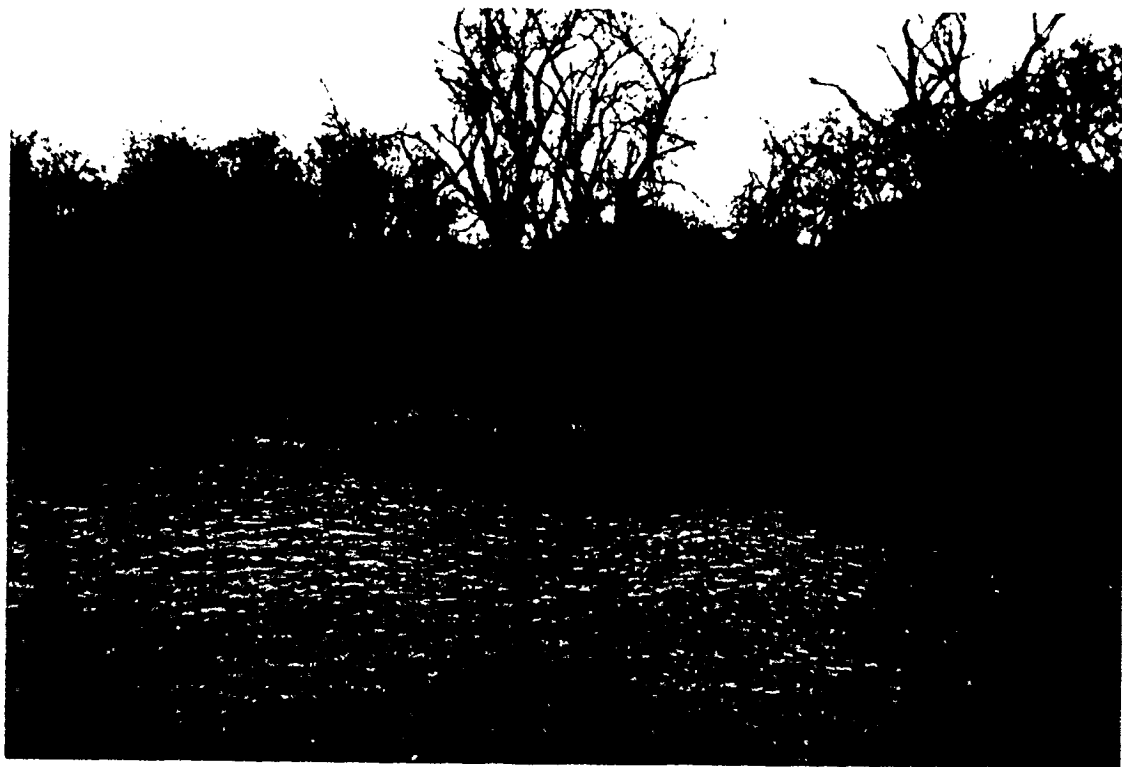
Stanislaus River, Mile 48.9, Honolulu Bar.  
Bottom of Mile 48.9 looking upstream.

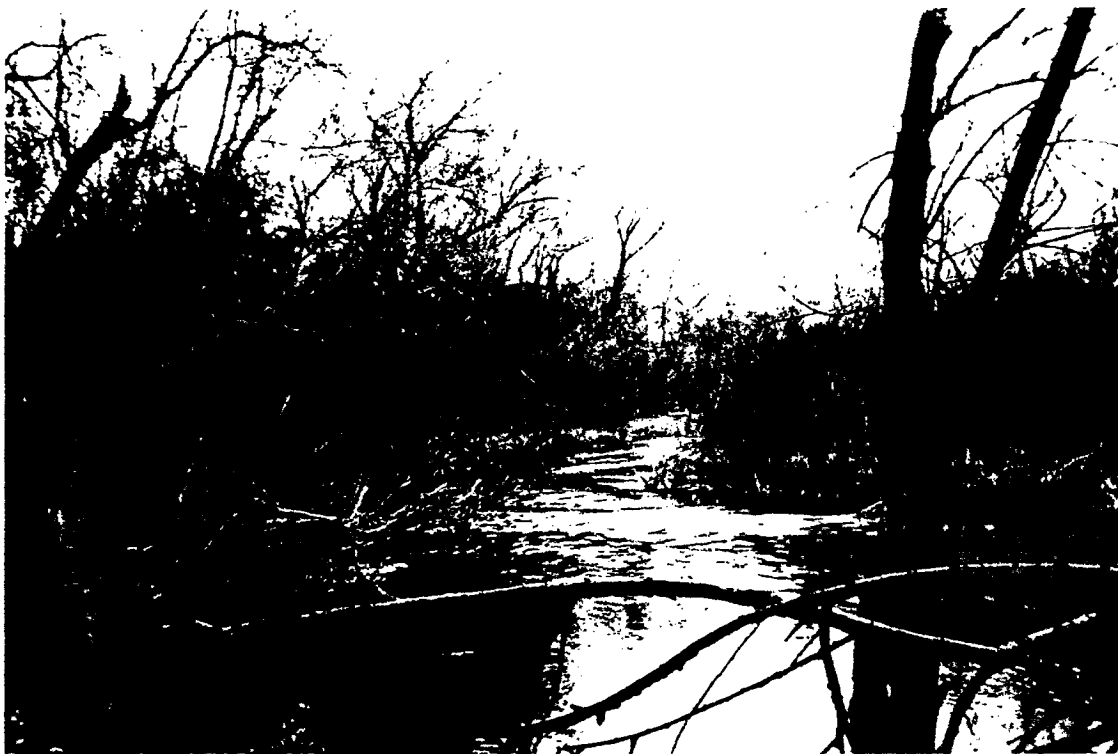
Stanislaus River, Mile 48.9, Honolulu Bar.  
Left side channel looking upstream.

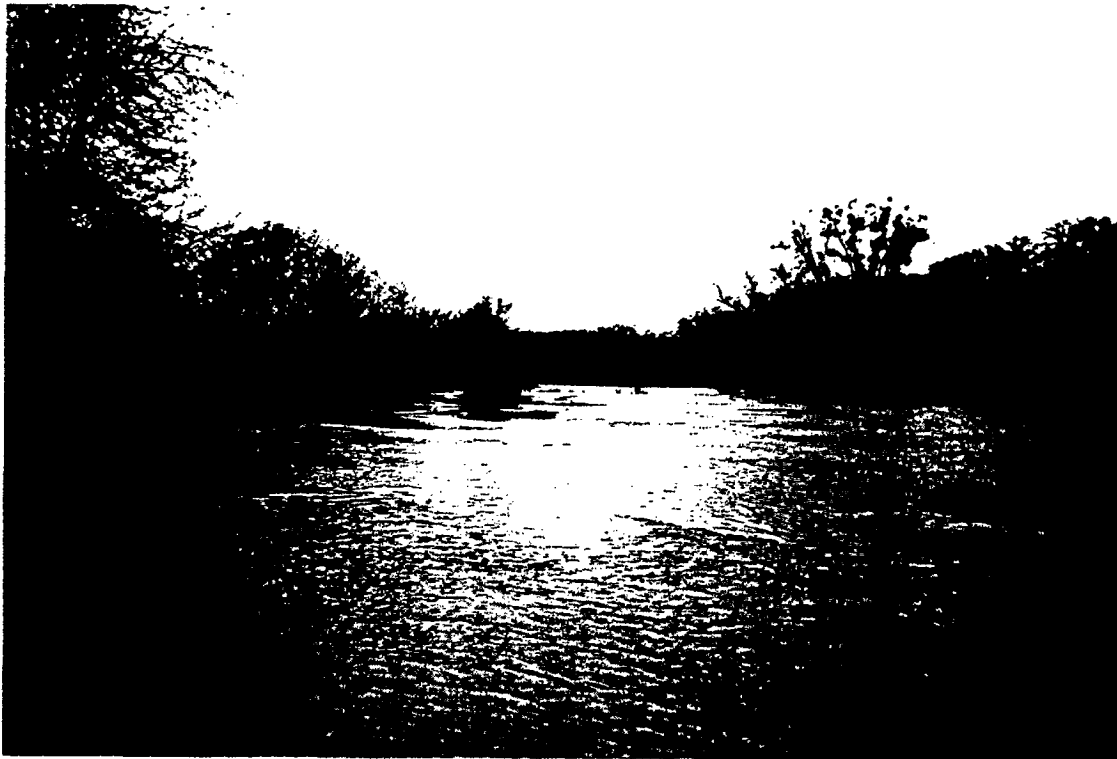
**Tuolumne River, Mile 48.5, Riffle 4A.  
Right bank looking upstream.**

The restored site will be approximately 100 feet wide and 880 feet long. Approximately 4,900 square yards of spawning gravel will be available after restoration.

The restoration is roughly estimated to cost \$172,000 and take four weeks to construct. No significant permitting issues are seen at this time.

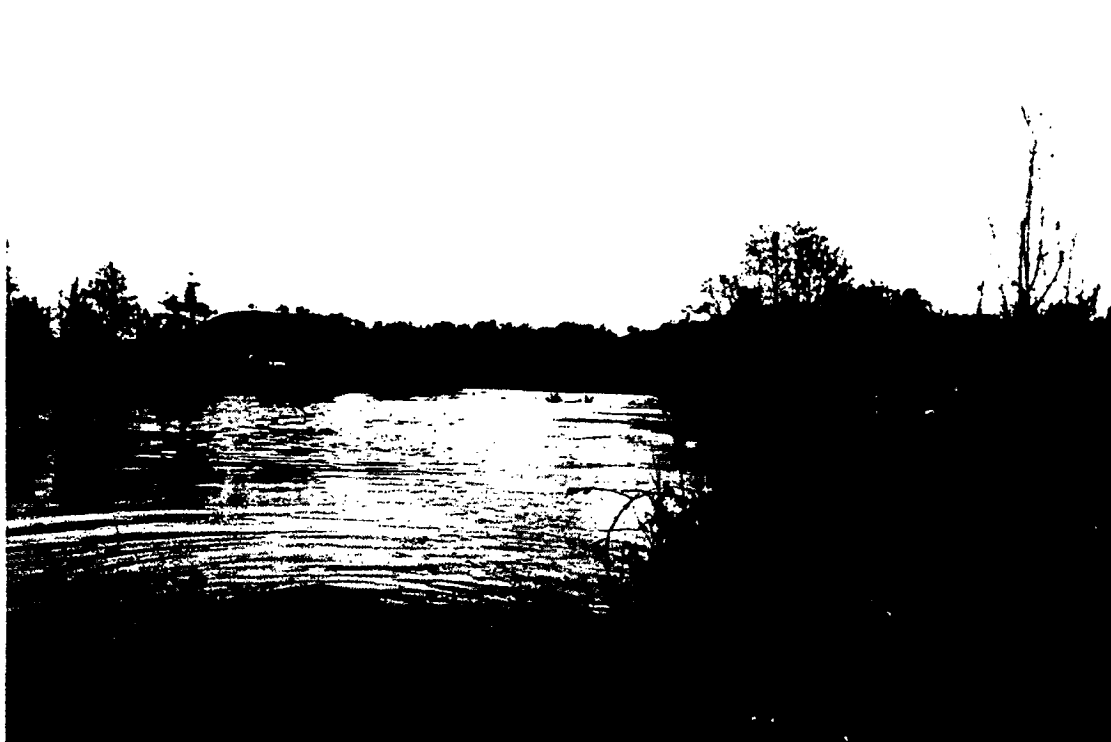
Tuolumne River, Mile 48.5, Riffle 4A.  
Right bank looking downstream.

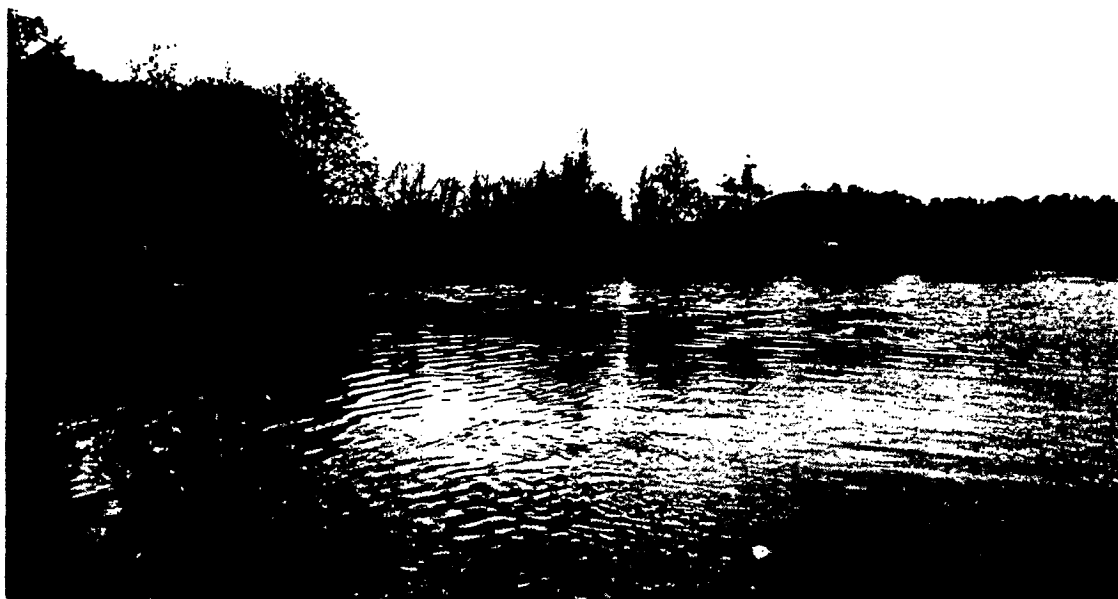
Tuolumne River, Mile 48.5, Riffle 4A.  
Left bank looking downstream.

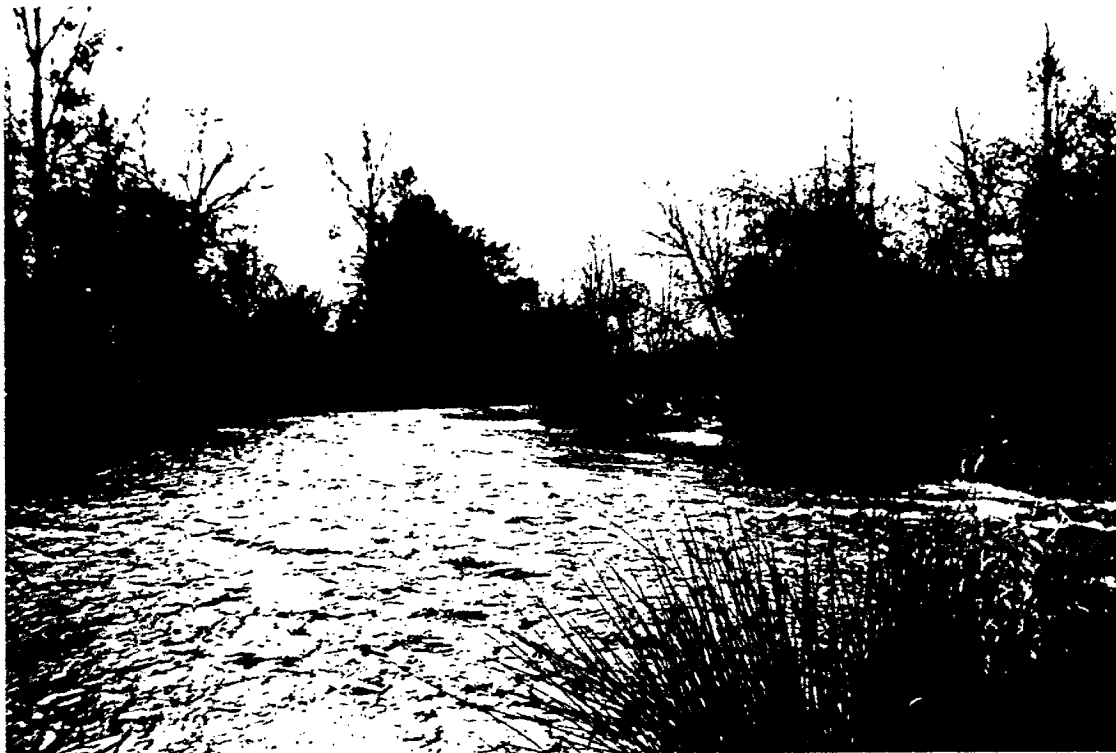
Merced River, Mile 48.4, Riffles 15 and 16.  
South channel looking downstream.

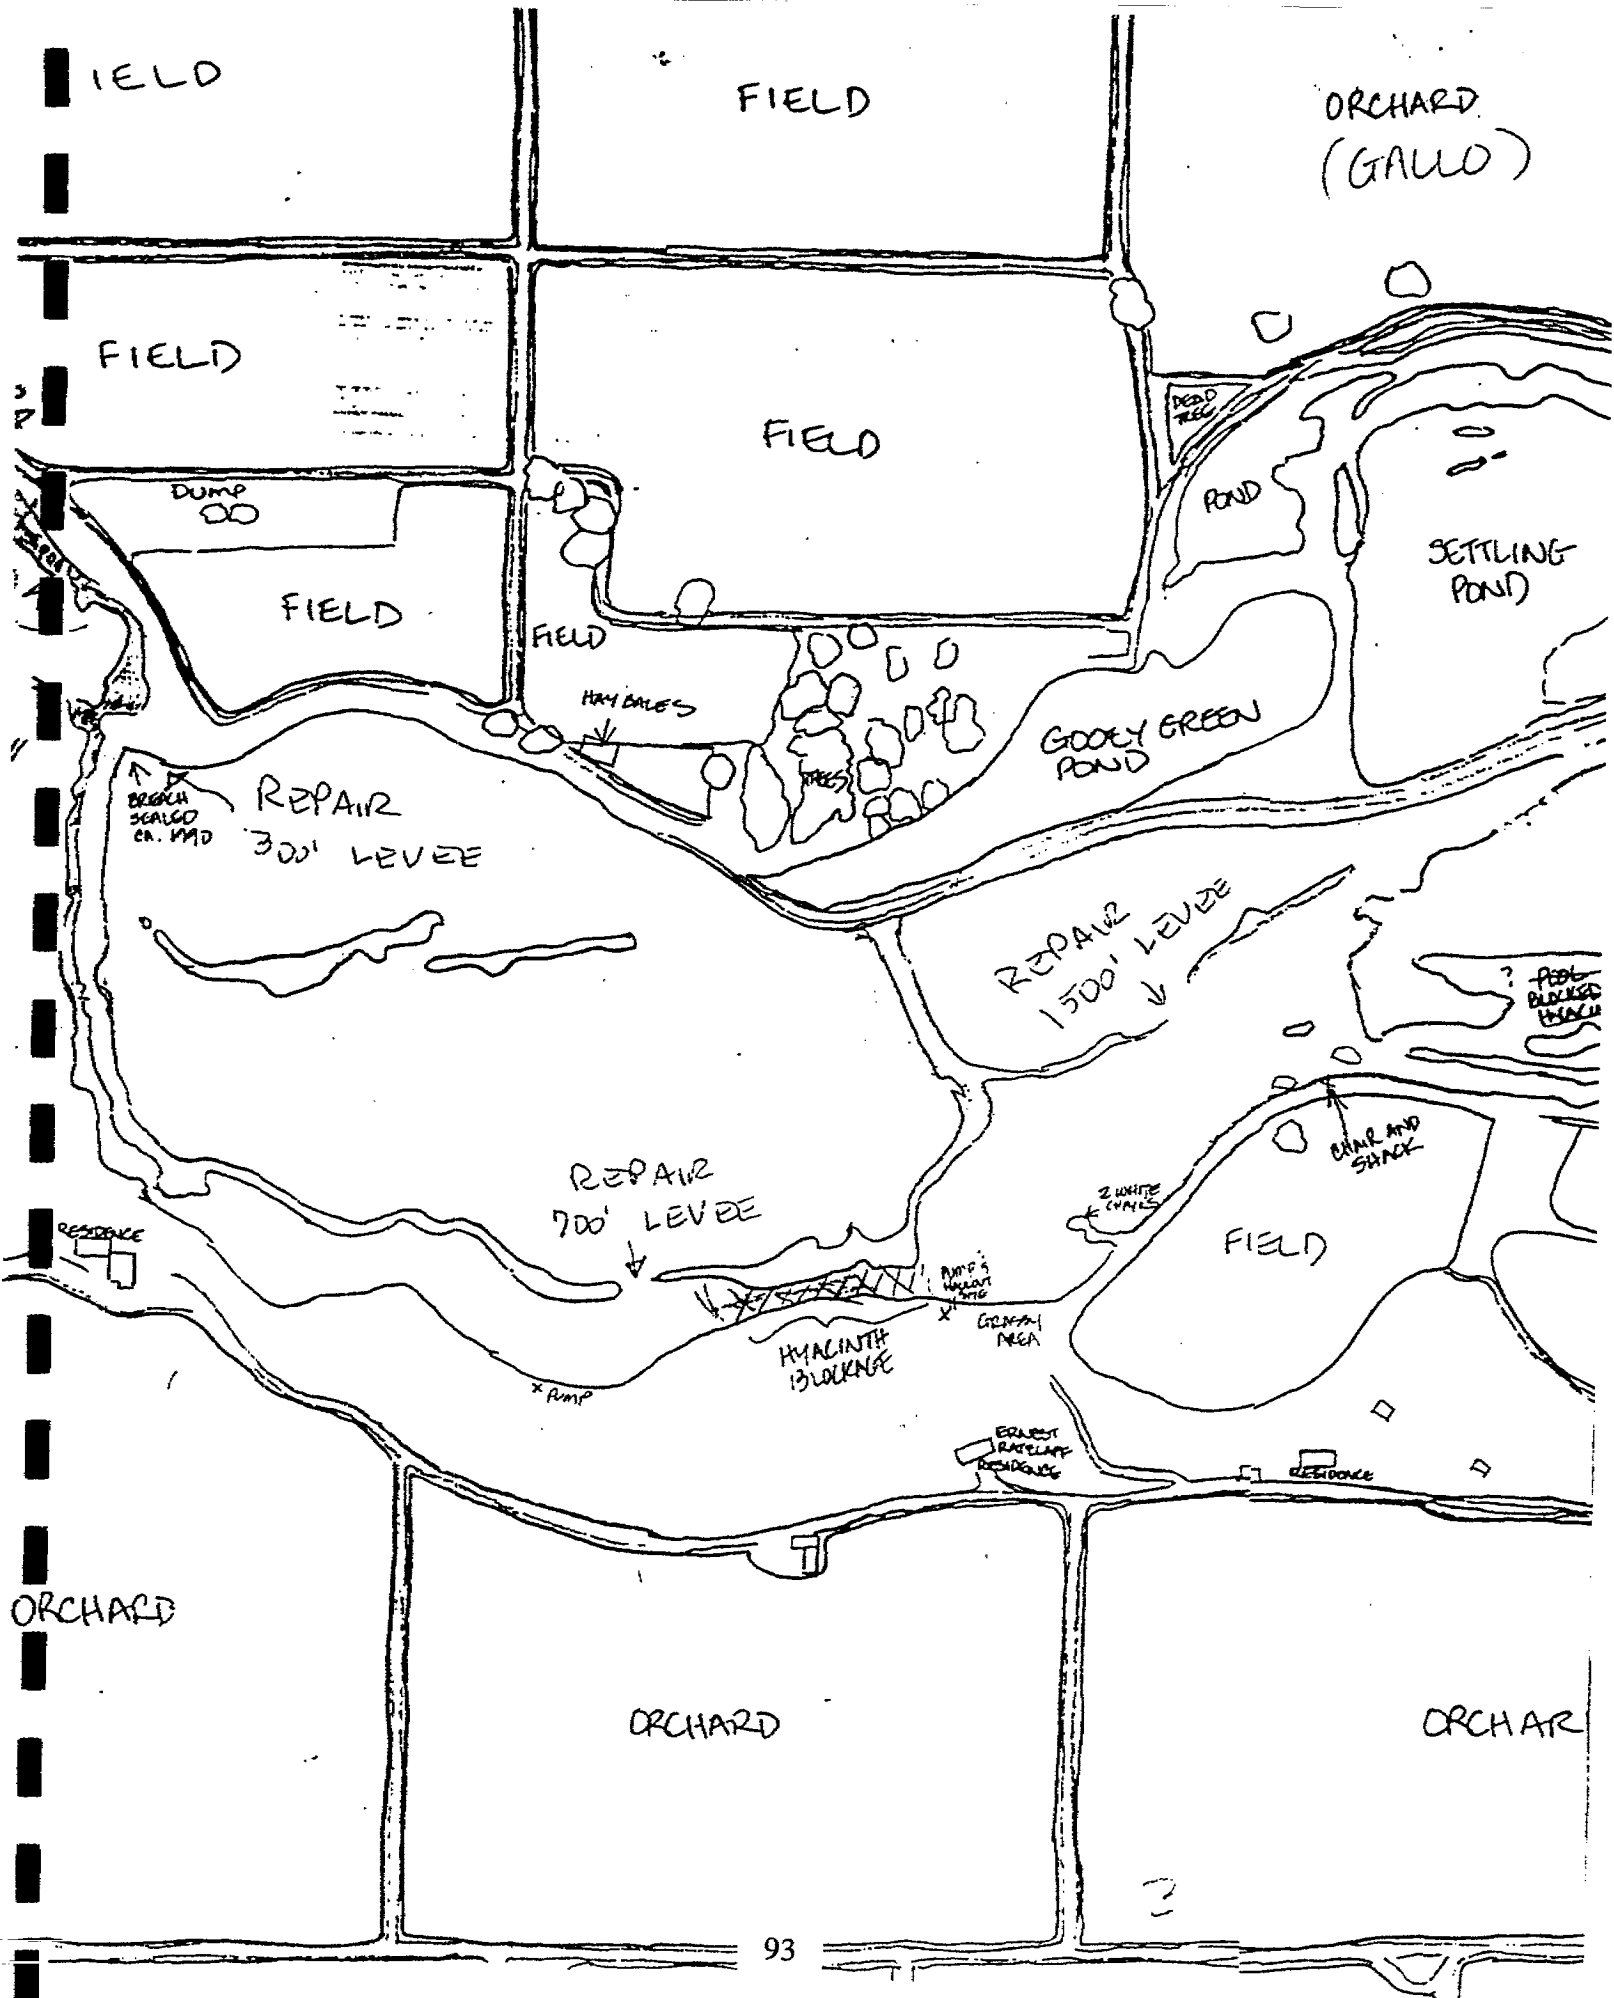
**Merced River  
Mile 40.1-40.5**

Approximately 200 acres of abandoned gravel pits have breached, and the river now passes through them. These pits provide prime habitat for predators of out-migrating salmon smolts.

Restoration would involve isolating the pits from the channel. Repairs to the levees are relatively minor in comparison to the large amount of predator habitat that could be isolated. Three breaches totaling approximately 2,500 feet would need to be sealed.

The actual construction costs would be minor compared to the benefits. However, the cost of preliminary surveying will be significant due to the size of the site, the vegetation, and the depth of water.
